## MedSun: Newsletter #41, October 2009

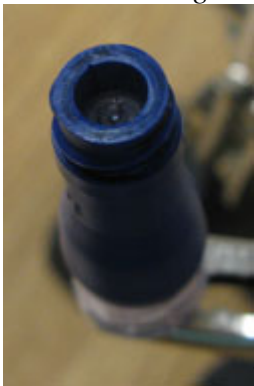
During IV and PICC line dressing and maintenance, as the clinician removes a male connection from the microclave connector, the spring loaded return mechanism sticks and does not seal the clave connection. This failure results in fluid leaking from the clave port which compromises sterility. We initially discovered this when we noted an increase in blood stream infections, and found this defect as part of our investigation. This failure is noted to occur after clave has been in position for up to three days. Our staff has been unable to provide lot numbers as packaging is discarded during initial use. One unit has had more than 12 failures of this type. The manufacturer has replaced the complete inventory. However, our clinicians have determined that the new product has exhibited the same sticking issue as the old inventory.

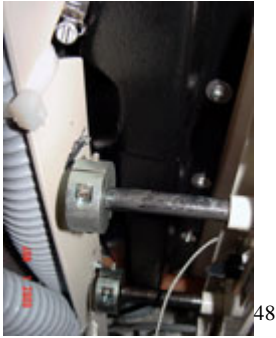
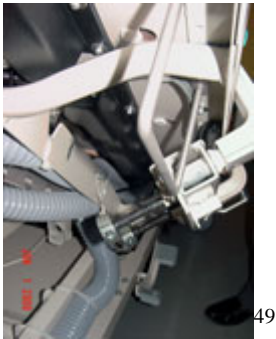
RN walking past door, found pt with knees on floor and upper body/head wedged between siderail and bed. Patient on air mattress with Posey Vest on. RN yelled to Tech for help, RN tried to hold patient up to keep from further slipping and strangling pt on siderail. Tech and other RN entered room, RN's holding patient up, patient kept slipping, more RNs entered room. RN yanked side rail out while other 2 RN's freed pt from siderail and helped lower the rest of the way to the floor. By this time room was full on RNs and MD was at bed-side to assess. Vitals were taken while patient was laid on floor and lift team was called. Bed was changed from air mattress to regular bed r/t regular bed a lot less slippery for patient. Patient was agitated and stated he had to go to the floor and wanted to get out of the hospital.
